# **Overhead Conductor Condition Monitoring ASTP/API Progress Report (No.2 2019)**

Power & Energy Systems Research Group  
School of Information Technology & Electrical Engineering  
The University of Queensland  
Brisbane, Queensland  
8<sup>th</sup> November 2019

This report was prepared as part of the “Overhead Conductor Condition Monitoring” project being funded by the Energy Networks Association Limited.

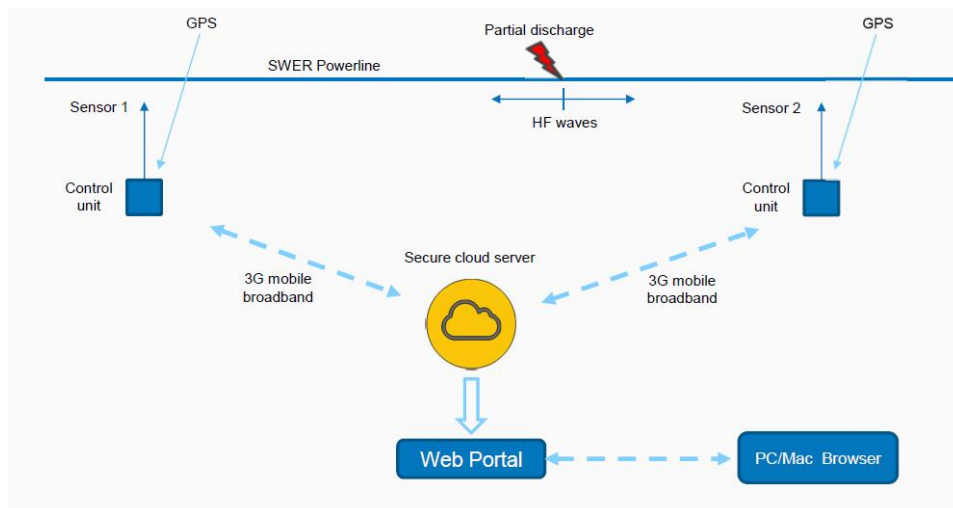
IND technology’s early fault detection (EFD) method is a continuous conductor monitoring solution. It can remotely detect and locate radio frequency (RF) signals emitted from a faulty section of a conductor. The sensors used are antennas or Rogowski coils (placed every 5 km), which can detect micro arcs or Partial discharge (PD) signals. The data captured by the sensors are continuously uploaded to a cloud-based information management system. The collected data is analysed using machine learning algorithms in real-time. Figure 1 illustrates the components of the EFD method.

**Figure 1 Illustration of IND technology’s early fault detection (EFD) method for continuous conductor monitoring [2]**

The EFD technology claims to be able to detect deteriorating, damaged and broken overhead conductors, powerline vegetation encroachment and line contacts.

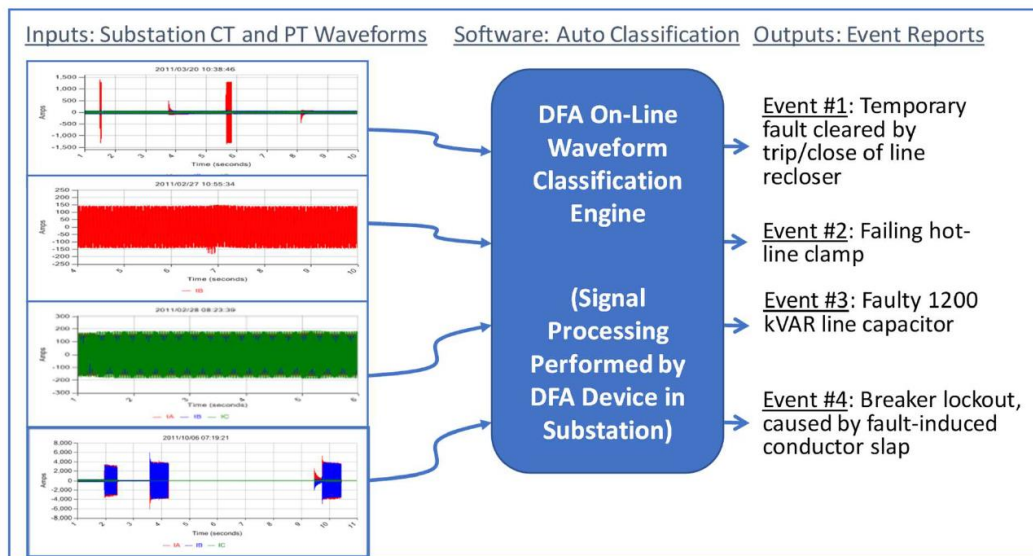
The LORD Technology’s DFA method is also an online real-time condition monitoring technology, which is intended to raise the asset managers awareness of the current system health condition and developing events. Unlike IND’s EFD, the DFA uses Current Transformers (CTs) and Potential Transformers (PTs) to perform the measurements. The CT and PT waveforms are then sent to a software tool for classification, as illustrated in Figure 2.

**Figure 2 Illustration of LORD Technology’s DFA method [3]**

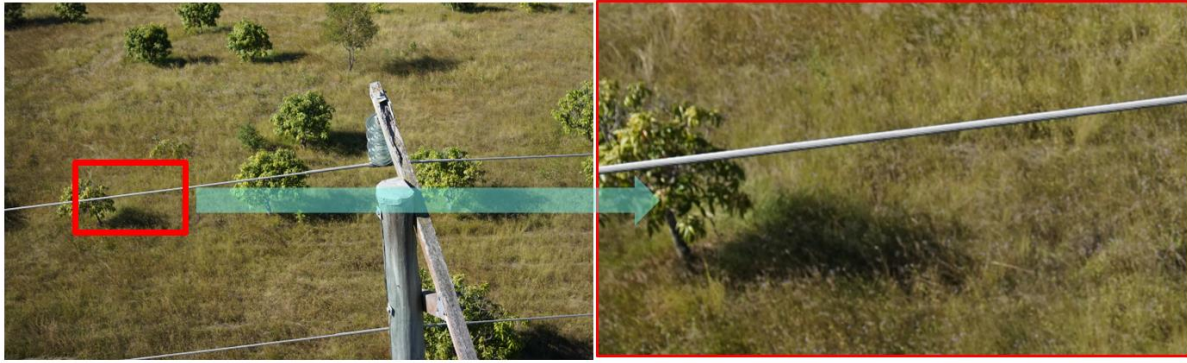
The UQ team has received sample drone captured images of overhead conductors form the project partners. An example is shown in Figure 3. The sample photos are of high resolution and can be used to identify defects and make an assessment of the condition of overhead conductors. However, proper intelligent techniques need to be implemented in a software environment to automatically analyse these photos/videos and evaluate the conductor’s condition.

**Figure 3 Sample Drone captured image of an overhead conductor**
