Overhead Conductor Condition Monitoring

Milestone Report 3

Power & Energy Systems Research Group
School of Information Technology & Electrical Engineering
The University of Queensland
Brisbane, Queensland, April 2020

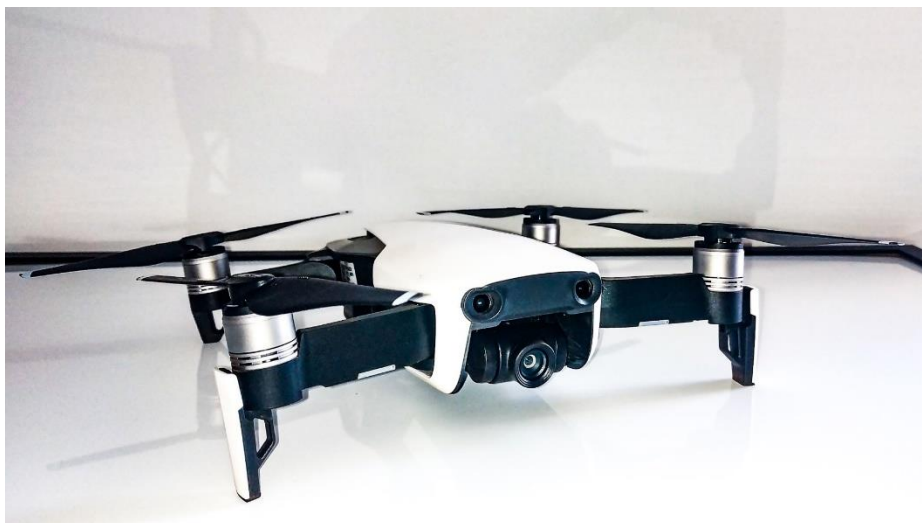
Figure 6 DJI Mavic Air drone

Conductor surface visual inspections were conducted using the recreational grade, light weight (430 g) DJI Mavic Air drone shown in Figure 6. This specific drone model was used for proof-of-concept testing specifically because it is an entry level photography drone with basic imaging technology. There are many other drone models available which are equipped with more advanced imaging techniques than DJI Mavic Air drone.

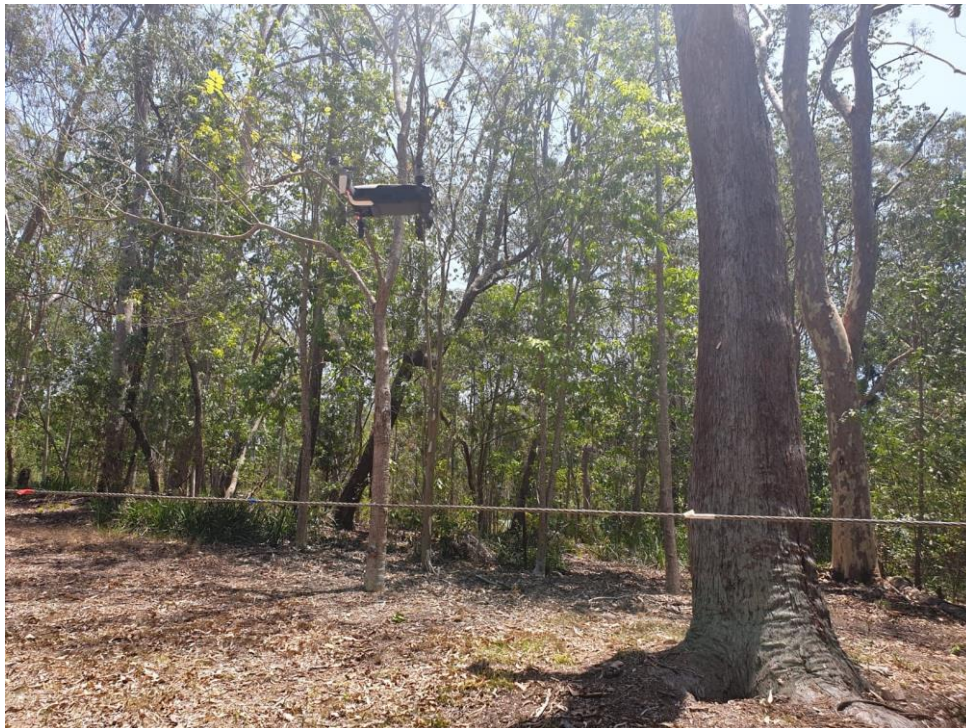
Figure 7 Conducting drone based visual inspections of a copper conductor in an outdoor location

Two trials were conducted in an outdoor location (see Figure 7) and a dedicated drone flying zone (Figure 8) at the University of Queensland. During both trials, an aged hard drawn 7/.064 (seven strands with each strand of 0.064 inches in diameter) copper conductor was used as the test object. The conductor was mounted about 3 m above the ground. As shown in Figure 7 and Figure 8, the drone was flown directly above the copper conductor to capture surface visual information.

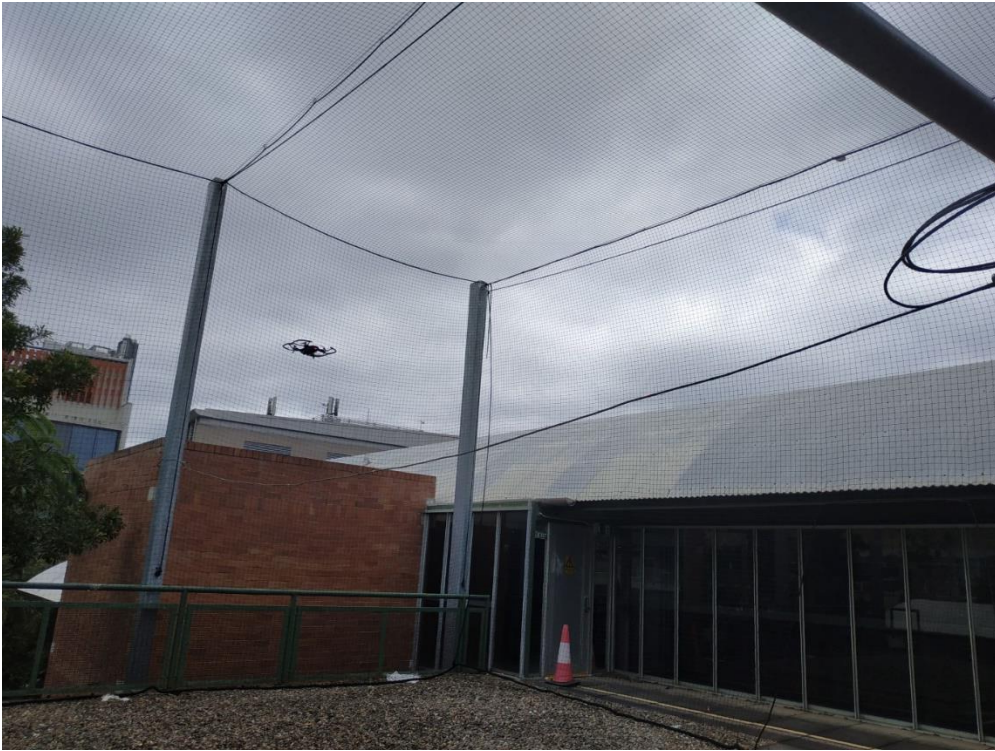
Figure 8 Conducting drone based visual inspections of a copper conductor in a dedicated drone flying zone

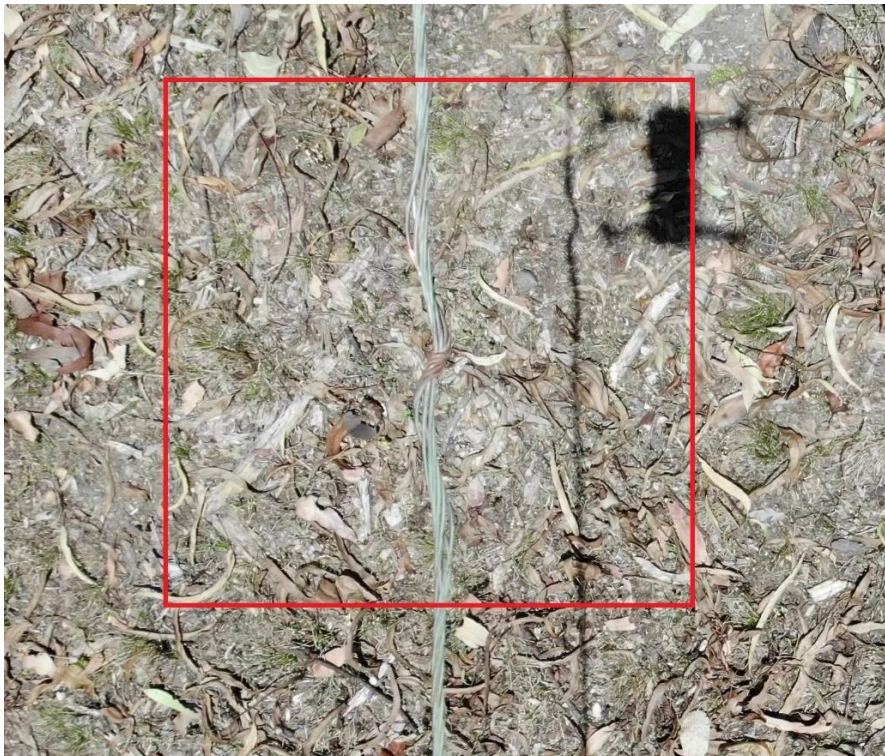
Figure 10 Loosened strands in the test conductor

The copper conductor used in this experiment had several defects including, an aged joint, loosened strands and loss of cross-section as illustrated in Figure 9, Figure 10 and Figure 11 respectively. Further, as can be seen in all three images, conductor surface has severe discolouration.

It should be noted that above images are frames extracted from videos recorded using a drone mounted camera. During the inspections the drone was flown approximately 1.5 m above the conductor. From Figure 9, Figure 10 and Figure 11, it is evident that the drone captured video footages of conductor surface contain information required to extract conductor defects on its surface.

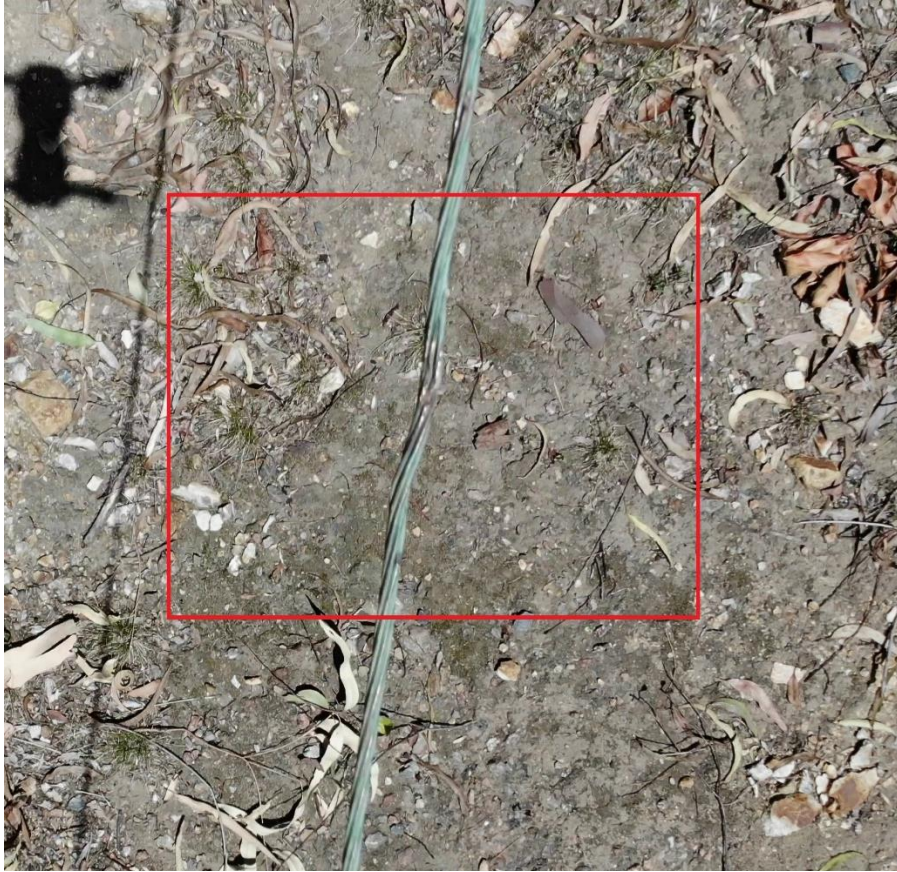
Figure 11 Loss of cross section possibly due to arcing in the test conductor.

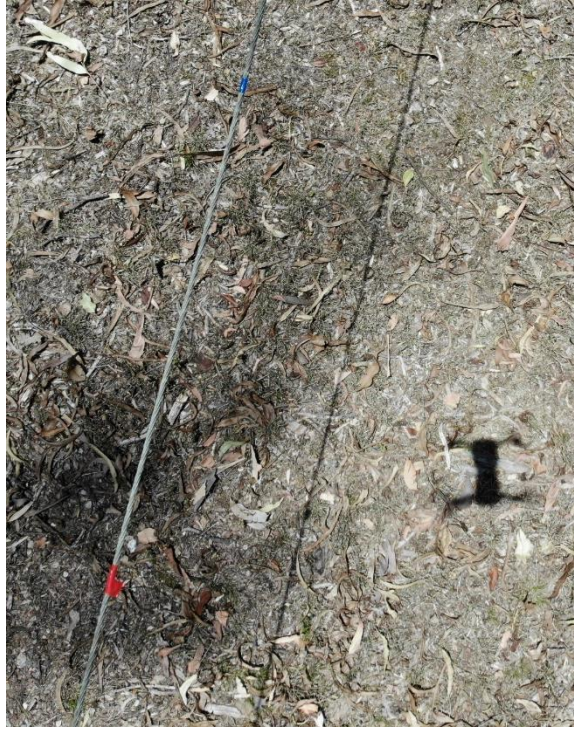
Figure 12 Red and blue markings on the conductor surface

To develop an automated machine learning based algorithm to detect surface defects, a large number of tagged images of each defect are required. However, such data are currently not available. Even though DNSPs have visual inspection data collected during routine inspections, tagging a large number of such data is not possible within the time frame of the current project. To overcome aforementioned challenges, in the conducted proof-of-concept tests, 2 cm wide markings were used to mimic three types of defects. The markings were made on the conductor surface using red, yellow and blue colour insulation tapes (see Figure 12).

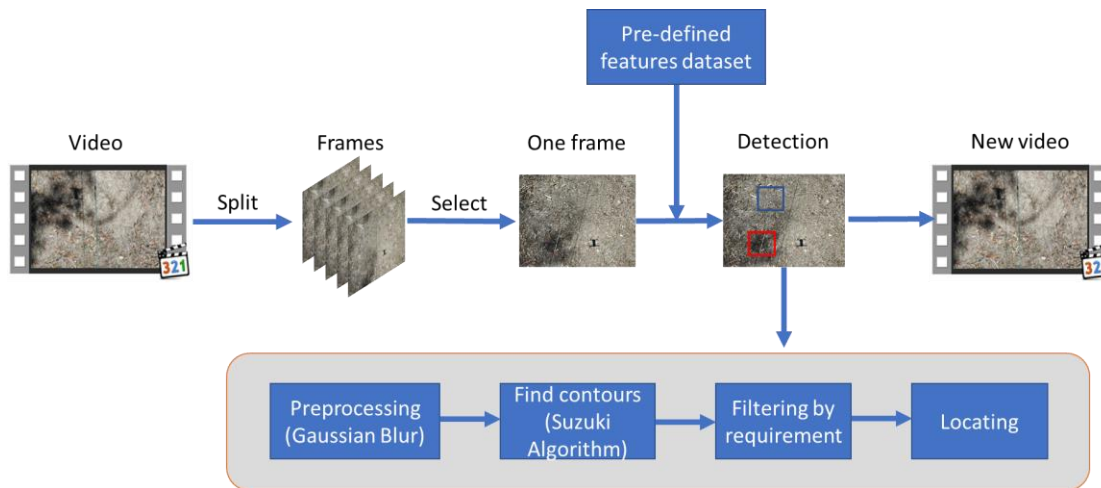
Figure 13 Main steps in processing drone-captured video and fault identification

The main steps involved in processing drone-captured video and fault identification are illustrated in the photos and flow chart shown in Figure 13.

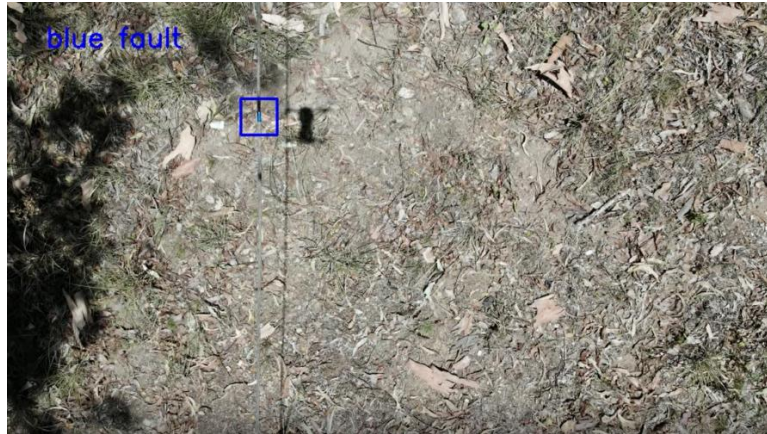
Figure 14 “Blue” defect automatically marked on a single frame by the proposed algorithm

A video file recorded during an outdoor trial was processed and analysed using the proposed algorithm. The algorithm was able to identify artificially created defects and mark them automatically on each frame as shown in Figure 14, Figure 16 and Figure 17. Further, the algorithm is capable of tracking an identified defect throughout the video until it disappears from the video (see Figure 15).

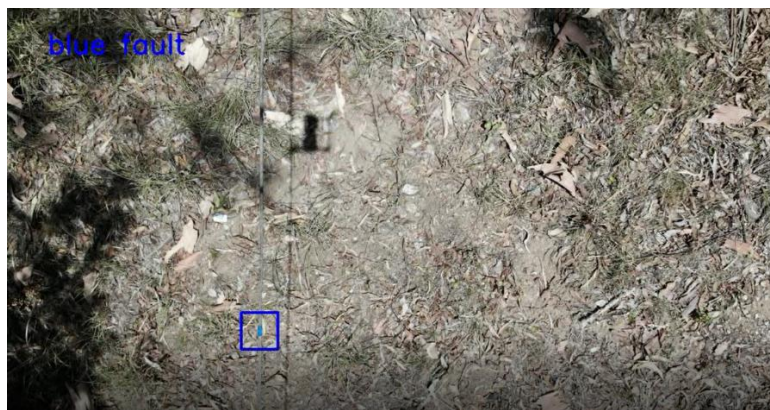
Figure 15 Detected “Blue” defect is being traced continuously by the proposed algorithm

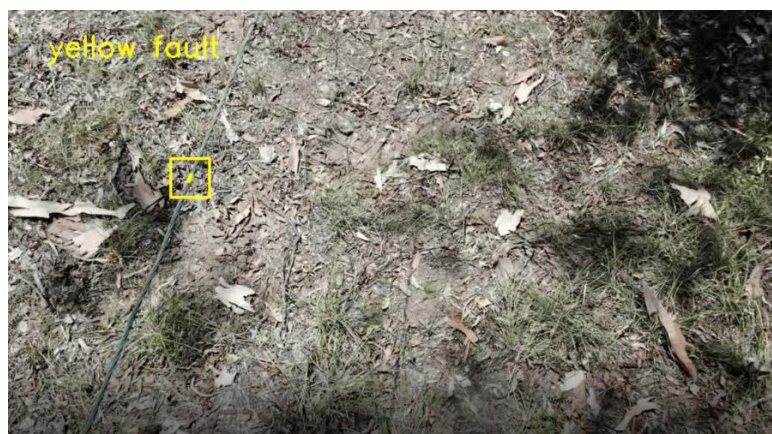
Figure 16 “Yellow” defect automatically marked on a single frame by the proposed algorithm

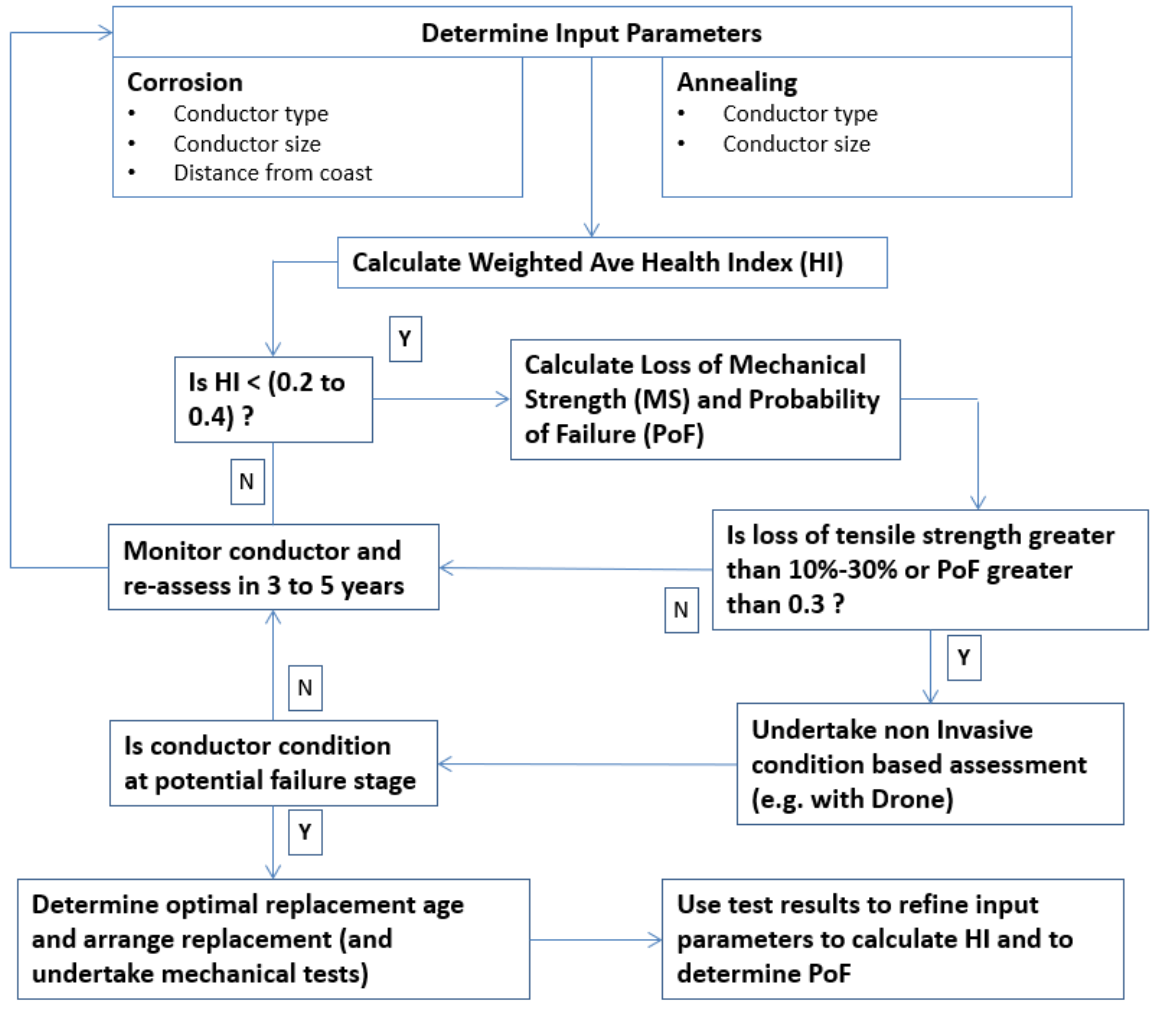
Conductor Condition Monitoring Process

Figure 18 Proposed Condition Monitoring Process for Distribution Conductors

The flowchart presented in Figure 18 outlines the proposed overall condition monitor process for conductors. There are trigger points for the predicted end of life (based on Health Index) and end of life criteria (based on loss of mechanical strength).

1. Undertake Drone trial on conductors when the Health Index is below the threshold (in range of 0.4 to 0.5) - which is the predicted end of life for conductors
2. Take images of any significant defect on these conductors
3. Take images of any joint or connector on the line
4. Assess the degree of degradation, with the end of life defects being:
 - a. Severe discolouration
 - b. Deep pit corrosion (greater than 30%)
 - c. Broken strands
5. Insert labels/tags on conductors which meet the levels of defects given in (4)
6. Determine if the defects are caused by localised events (e.g. lightning, conductor clashing, vegetation impact etc) and which the defects can be repaired
7. For the long-term defects count the number on a per feeder or per km basis – this can then be used for the strategic management of conductors
